## EXPERIMENTAL STUDY OF LOCAL BEHAVIOR OF STRENGTHENED REINFORCED CONCRETE SHORT CORBEL BY BONDING CARBON FIBER FABRICS

Mutyala Manoj Kumar<sup>1</sup>, Dr.B.Arun Kumar<sup>2</sup>,

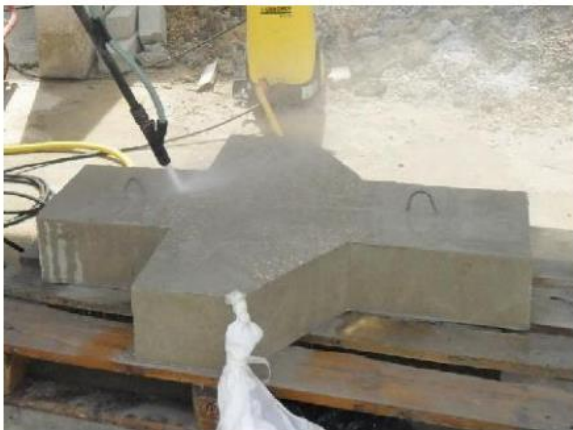
**Figure 1: Surface Treatment by Sandblasting**

The unidirectional and bidirectional fibers are used. The experimental results obtained for carbon composite unidirectional are showed in Table 1. The yield strength corresponds to the tensile strength. The carbon composite sheets have a linear elastic behavior up to failure. The high elongation at failure is 0.8% for the unidirectional carbon fiber sheet and 0.5% for the bidirectional carbon fiber sheet. Table 1 shows the characteristic properties of used composite materials. The surface preparation was of primary importance and calls for care (Figure 1). Preparation of concrete surfaces must be carried out to remove any loose or weak material, oil, grease, etc. In this case grit blasting was being the good method. The four corners of the corbel are rounded to reduce the decrease in strength and to prevent tearing of the composite material. Preparation of surface should be carried out just prior to the bonding operation to prevent anycontamination. After, the contamination can be avoided by applying the glue to the concrete

and carbon fiber fabrics is applied with the brush. The concrete surface has already become roughened and then leveled before sticking on the wraps using

epoxy adhesive. Pressure must be applied to squeeze out excess glue and held the plate in place until the glue has hardened. Resin and hardened glue is just mixed before the gluing operation.

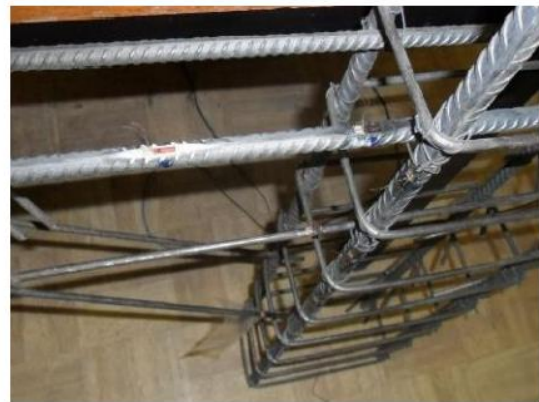
**Figure 2: Position of electric gauges on underwood of reinforced concrete corbel**

gauge factor 2.09. The strain gauges are attached to each of the experimental specimen. Precision strain gauges length of 5 mm (Figure 3) are used to measure the strain on the main steel reinforcement (Figure 2) as well as horizontal frame, steel tie rod placed along the tension and the compression strut. The strain gauges on the face of the corbel are placed in shear span between the corbel and the column. Two of gauges length of 10 mm are placed on the composite fibers plate surface and one gauge length of 30 mm on the concrete.

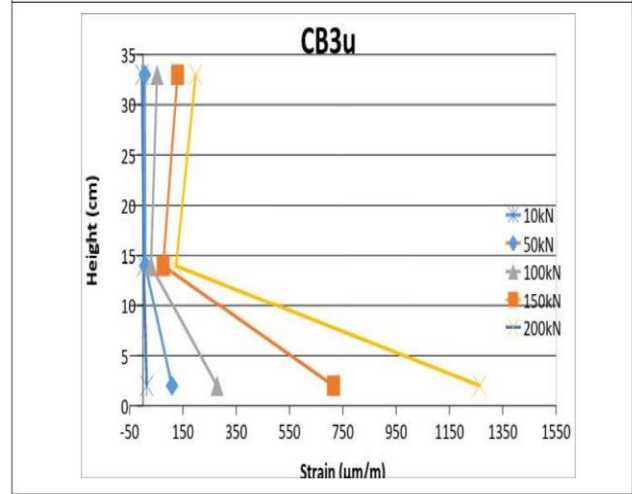
Figure 7: Position of Neutral Axial Versus Applied Load for CB3u

Concrete surface strains at a section close to column face of the tested corbels were measured by using three strain gauges over the depth of the corbel. Figures.6 and 7 show the concrete strain distribution over the corbel depth for all corbels at different load levels. In these figures, it can be seen that the strain distribution was approximately linear in tensile and compressive zones at low load levels, and then became increasingly nonlinear at the tension zone at higher loads due to cracking effect. For all tested corbels, the neutral axis was shifting upwards after increasing the load beyond than the load at first crack. The position of the neutral axis for small load (10 kN) is about 15 cm, for which reason the width of the plate is less than or equal to this value.

The contribution of strengthening reinforced concrete short corbels is very significant and interesting. Result shows an increase in failure tensile strength more than 1.82 by bonding carbon fiber fabric. The bonding composite carbon fiber fabrics slightly changes the position of neutral axis. But for loads less than 150 kN, the strain distribution in cross section appears linear. Beyond this value, the strain distribution is nonlinear as in Figure 6 and 7. Result show that strengthening by wrapping remains still

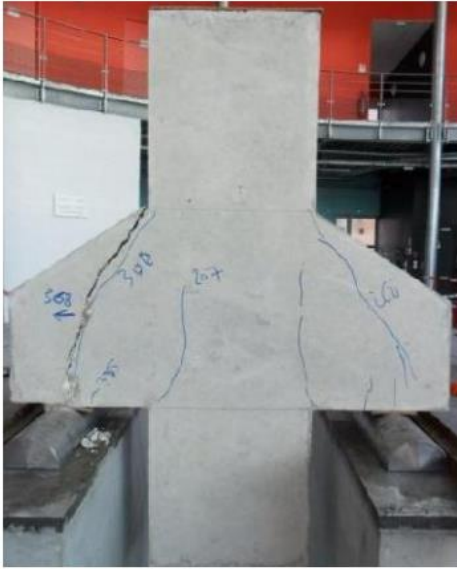
a) C0 : Flexion failure

The results, as shows in Figure 8(a), 8(b), 8(c) and 8(d), distinguished mainly three types of failure: flexion failure, shear and fabrics peeling off and compression failure. Although, CI2b and C0 were the same rupture, noted that cracking

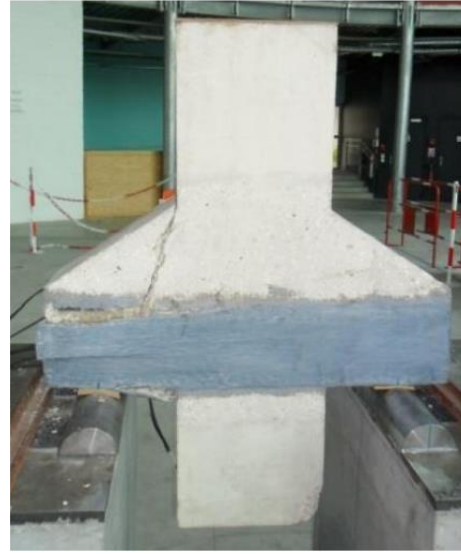
c) CP3u : Shear collapse with fabrics peeling off

This specimen was strengthened with externally bonded three horizontal fabric strips. There is only one major diagonal crack started at the bearing plate, and propagated towards the junction of the column and face of the corbel. This crack appears at a load of 310 kN and causes failure of the corbel. The corbel failed at an ultimate load of 380 kN. When the number of fabric strips is increased, the ultimate deformation of the corbel is caused by peeling off the strips of cloth. The accumulation of several strips of fabric on top of each other results in a thickening of the layer as a whole, and therefore, they peel off easily and cannot reach to the maximum load-bearing capacity of the composite. There was no apparent damage to the fabric, just concrete cracked major diagonal shear crack beneath the fabric. The concrete crack caused of debonded fabrics on the front and rear face of the corbel.

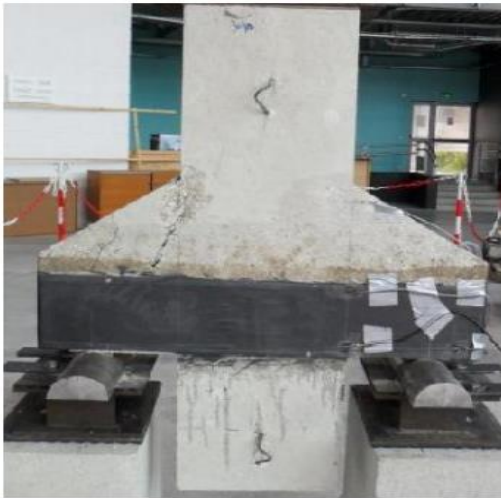
b) CB3u : Compression failure

First flexural cracks appear at 140 kN and then appearance of the bearing at 365 kN. Probably the appearance of diagonal cracks plays a lot because of the positive move in after the landing. It shows the comparison of curves obtained by gauges “G1” (steel tie local deformation) for four different corbels. These curves are compared to reference reinforced concrete corbel without strengthening. The results show that curves are similar and ultimate load increases with a third reduction of deformation. The failure and crack patterns of the group strengthening with externally bonded one horizontal strip of fabric. In all four cases, first micro cracks is started at approximately the same load between 130 and 140 kN. There is one main diagonal shear crack almost at an angle 45 degrees and this crack is started at the bearing plate. This crack caused failure of the corbel. Corbel failed at ultimate loads at 651 kN.

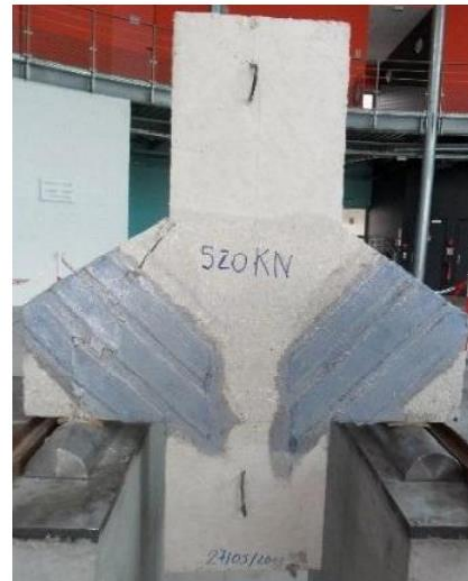
was different with appearance of a slight compression in CI2b.

First flexural cracks appear at 116 kN. As with the above specimen CP3u, there is only one major diagonal crack started at the bearing plate, and propagated towards the junction of the column and face of the corbel. This crack appears at a load of 380 kN and causes failure of the corbel. The corbel failed at an ultimate load of 520 kN. There was no apparent damage to the fabric, just concrete cracked major diagonal shear crack. The collapse of CI2b is appeared by Shear failure diagonal crack of CFRP fabric
